PROM Replacement

System Firmware Upgrade - CA150

CA150 System PROM Replacement

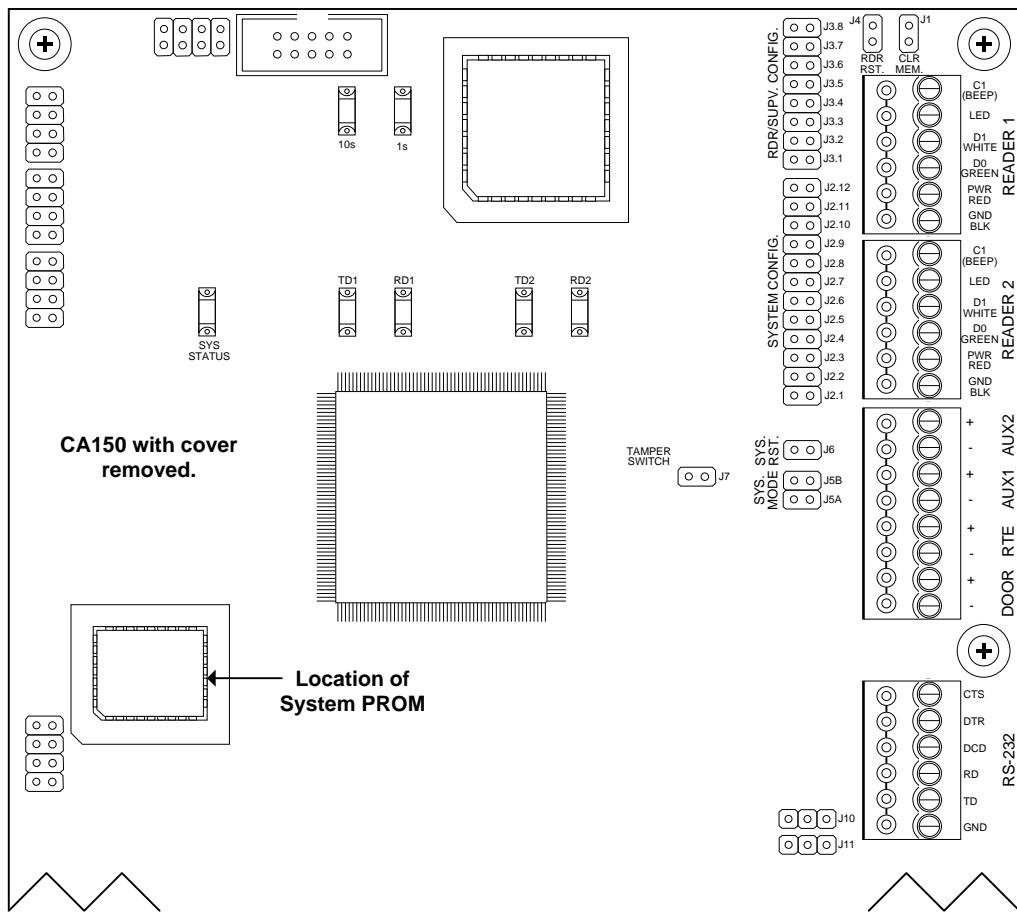
Figure 1 - System PROM Location

To install a System Upgrade PROM, follow the steps outlined on the next page. Figure 1 shows the location of the system PROM chip with the protective cover removed.

- Locate the system PROM chip on the control board as shown in Figure 1.
- Note the system PROM socket has two slots positioned at 11:00 o'clock and 5:00 o'clock.

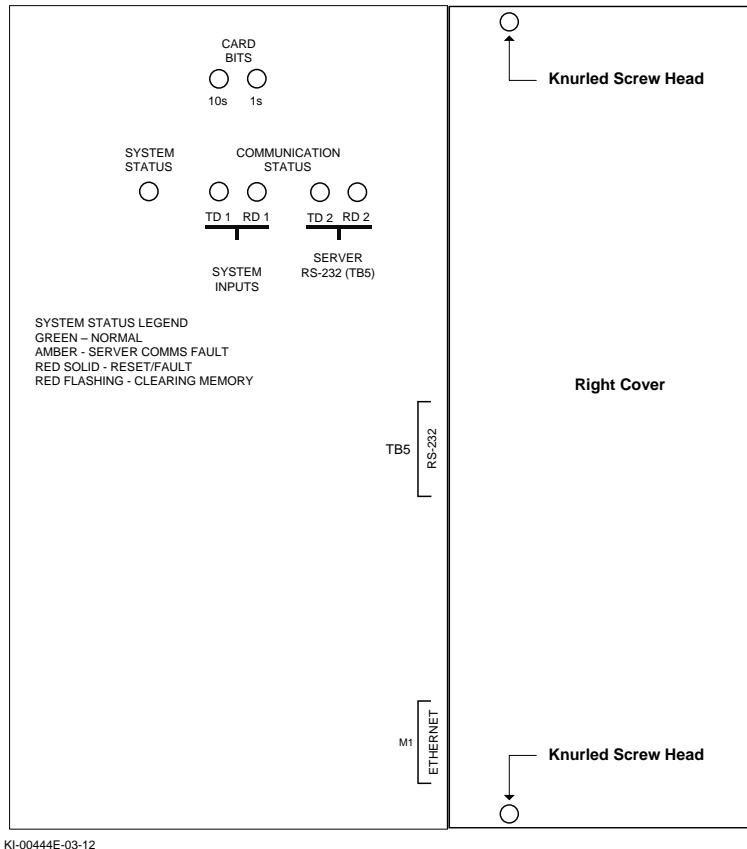
1. Unfasten the two (2) knurled screws and carefully remove the right side cover.

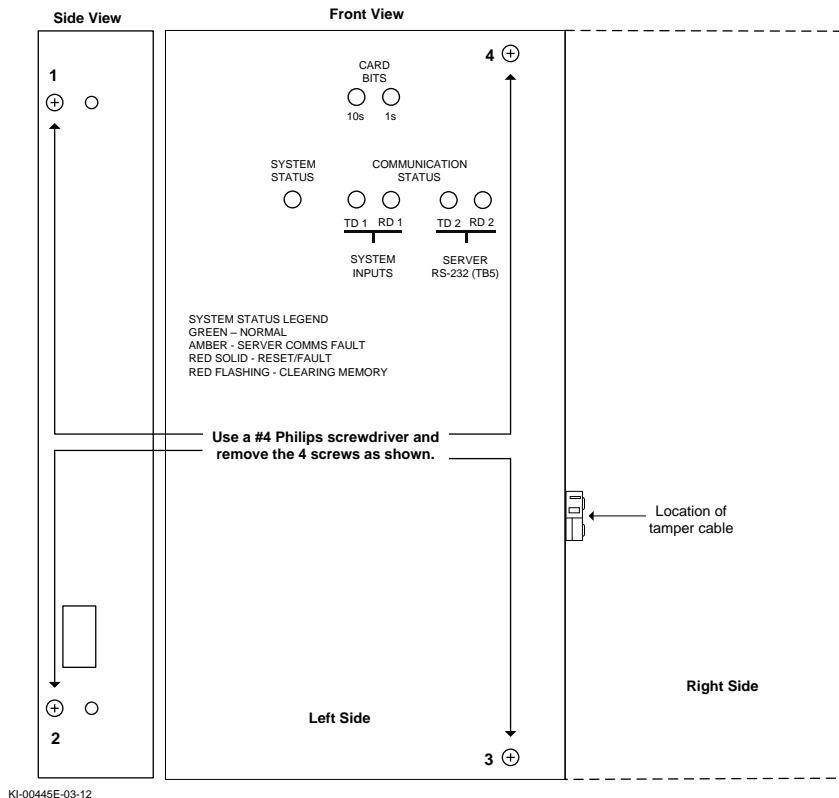
- Using a #4 Phillips screwdriver, unfasten the four (4) screws holding the left-side protective cover as shown in the illustration below. Partially pull the cover away until you see the tamper cable. Disconnect the cable from the CA150 circuit board at the J7 terminal. Leave the tamper cable connected to the cover and set the cover aside.

Before you begin step 3, be aware that the left side cover has a cable that is attached to a tamper terminal on the CA150 circuit board. When you unscrew the left-side cover, be sure to pull the left side cover away slowly and gently disconnect the cable from the J7 terminal on the circuit board as instructed.
